Urban lake management strategy: Effect of distinct types of lake surroundings and shorelines landscape development on water quality of urban lakes in Megacity Jakarta

Cynthia Henny^a and Ami. A. Meutia^b

^aResearch Center for Limnology-Indonesian Institute of Sciences (LIPI), Cibinong16911, Indonesia

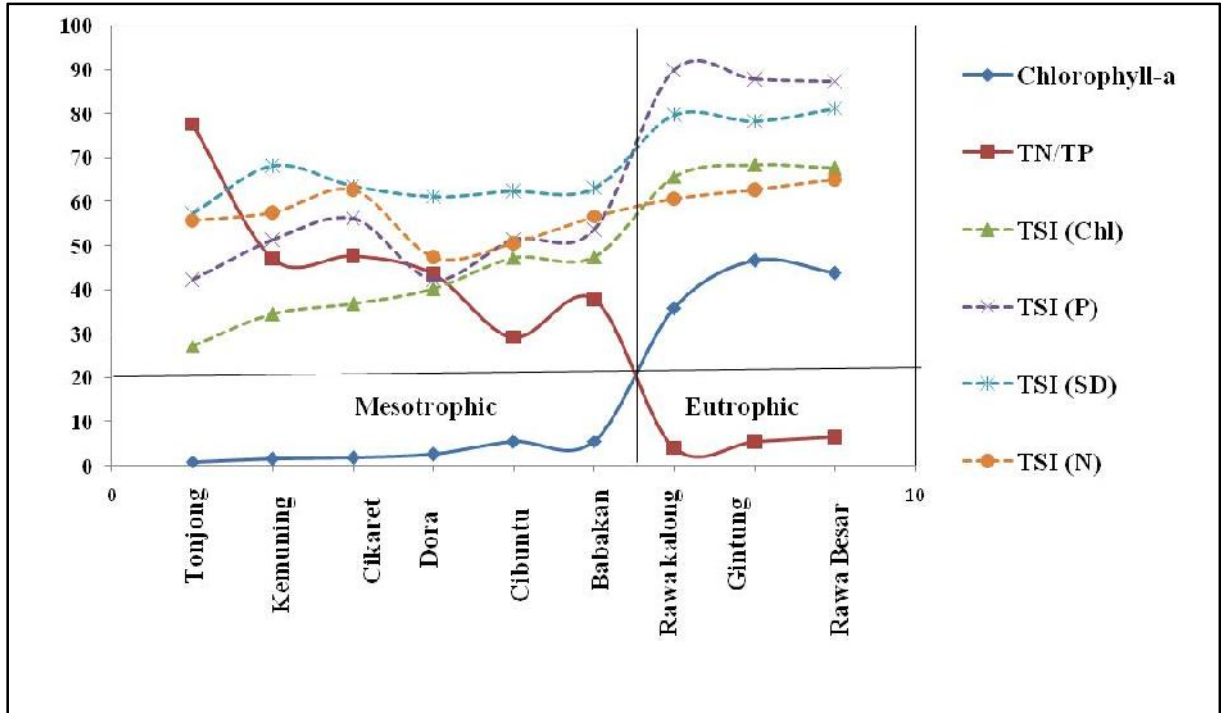
Fig. 2. Trend of TSI in association with TN/TP ratio and chlorophyll-a

Figure 2 shows the trends of TSI values for all variable and the association of all variables including chlorophyll-a and ratio of TN:TP. The cross line indicates boundary for TN:TP ratio and TSI values classify the trophic status of lakes. The boundary condition between mesotrophic and eutrophic conditions lies on TN:TP ratio=20 and on TSI values > 50 according to each variables. Strong positive correlation also are indicated by the correlation of Chlorophyll-a and TSI(P), TSI(CHL), and TSI(SD) but showing slightly lower Pearson correlation coefficient with TSI(N) (Table 5). The latter TSI of three variables can be use as the best predictor for lake status trophic. The boundary condition values of this study are consistent with Carlson and Simpson's number. Previous study in a shallow lake in China also obtained the same results on the TN:TP ratio value, where the TN:TP ratio value of < 20

in the lake indicate no sign of eutrophication and the phosphorus is the limiting nutrient to the lake (Yang et al, 2013).

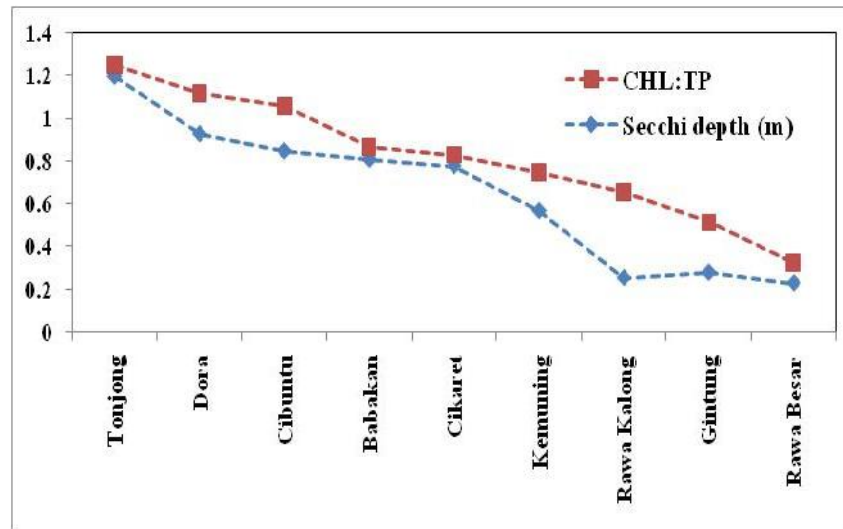
Fig. 3. Trend of CHL:TP ratio and secchi depth

To make certain that phosphorus is the main factor of controlling the algal blooms the value of ratio of chlorophyll-a:TP can also be used. The ratio value measures the efficiency with which TP is transferred into algal blooms (i.e. as an indicator of P limitation) (Spears et al, 2013). The lakes which indicated the eutrophication problems with algal bloom had lower ratio of chlorophyll-a:TP (Fig. 3). All results suggest that P can be limiting nutrient and is the major factor controlling the eutrophication of algal blooms problems in the urban lakes studied.

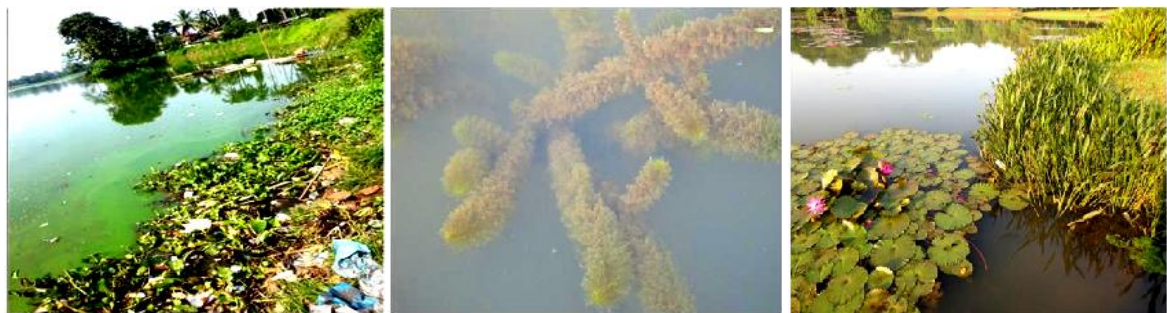
Fig. 4. The algal scum, floating macrophytes (left); submerged macrophytes of *Hydrilla verticillata* (middle) and emergent macrophytes (right) in Lakes Gintung and Dora respectively.

Eutrophication problem has known to reduce water clarity, decline in fish community, increase nuisance algal blooms and possible fish kills due to low dissolved oxygen and decrease the health of lake's ecosystem by far decreasing the amenity of urban lives. Figure 4 shows one of the urban lakes indicating the eutrophication problems with algal scum and microcystis and widely spread of *Hydrilla verticillata* and controlled emergent plant.

megacity Jakarta. Lakes with less pressures of urban activity such as rural village with more natural shoreline development and more green open space have better water quality and face lower eutrophication problems. Submerged and emergent macrophytes only observed in Lakes Dora and Cibuntu from all of studied lakes. Both lakes had better water quality and less turbid water. Lake Tonjong also showed also slightly better water quality although no submerged macrophytes observed in the lake and only limited types of riparian macrophytes are present. Lake Cibuntu is slightly well managed based on the growth of submerged macrophyte. Uncontrolled submerged macrophyte in Lake Dora is associated with sedimentation and decrease in lake depth where light penetration can reach lake's bottom. As in Lake Cibuntu, rehabilitation and sediment dredging has increased lake's water quality. Deeper lake can control excessive growth of submerged macrophytes. Tables 8 and 9 present the types emergent and submerged macrophytes in Lakes Dora and Cibuntu (Kurniawan, 2014). Controlled submerged and emergent macrophytes usually prevent algal bloom eutrophication and can maintain aquatic life especially fish in the lake. Submerged macrophytes can restrain resuspension of bottom sediments which lead to better waer quality of eutrophic shallow lakes (James et al, 2004). More natural shorelines development with green open space, maintained submerged and emergent macrophytes and good water quality can support more aquatic lives including butterflies and dragon flies which have been a bioindicator for good quality aquatic ecosystem.
